Mākaha Valley Flood Study

Community Meeting No. 2 September 23, 2014

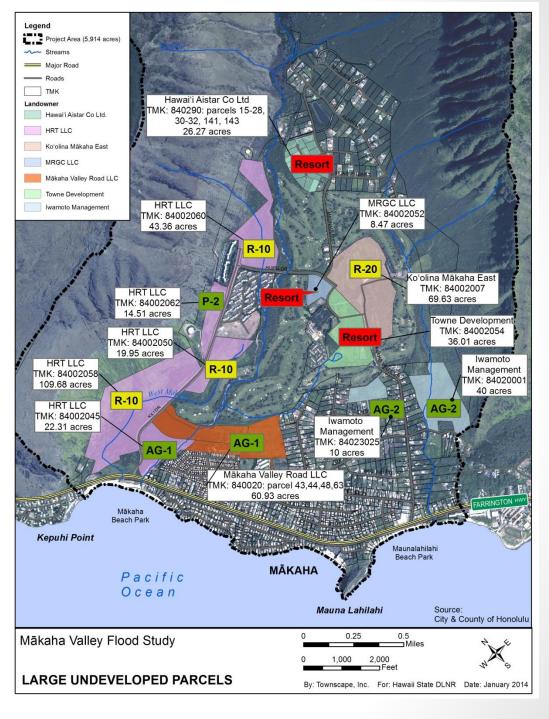
Large Undeveloped Parcels

- 13+ large undeveloped parcels
- Total 462 acres
- Zoning could allow for single family homes, hotels, duplex units, recreational facilities

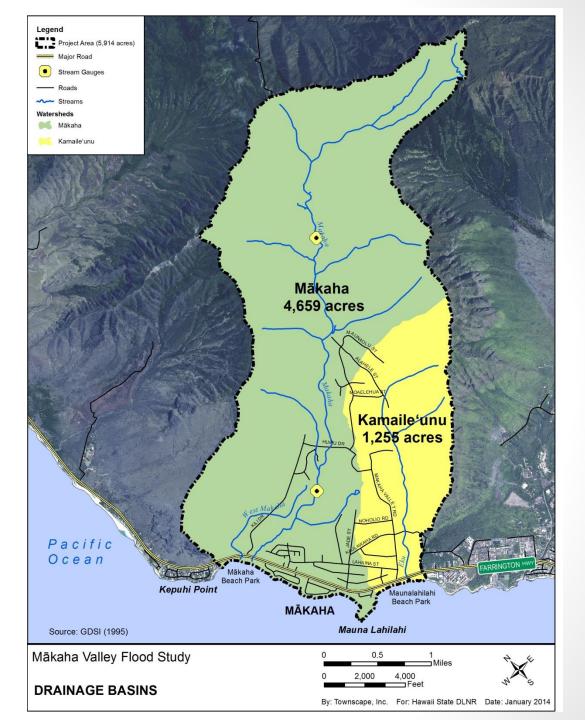
Drainage Basins

- 75% of the valley drains into
 Mākaha
 Stream
- 25% of the valley drains into
 Eku Stream

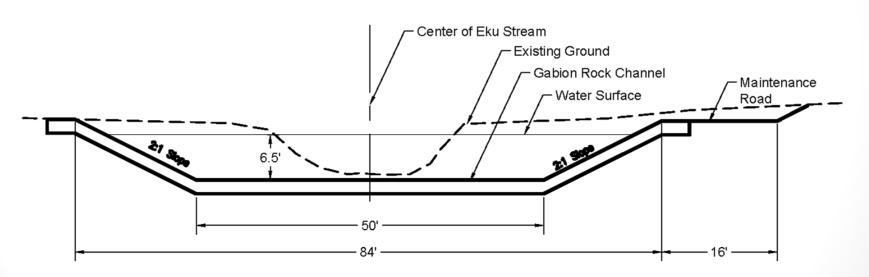
Project No.01: Eku Stream Channel and Off-line Detention Basin

Eku Stream - Gabion Rock Channel

Looking Makai

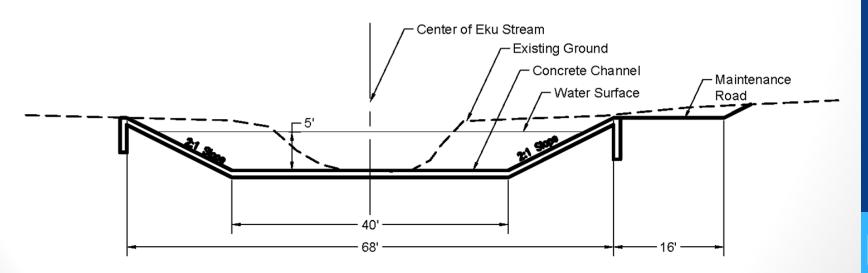
Project No.01: Eku Stream Channel and Off-line Detention Basin

Eku Stream - Concrete Channel

Looking Makai

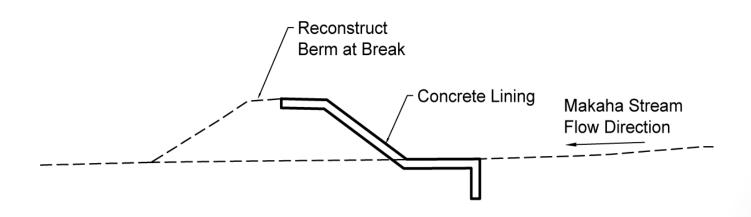
Project No. 03: Repair the Breach in the Mākaha Stream berm

Repair Makaha Stream Berm

Looking Westerly

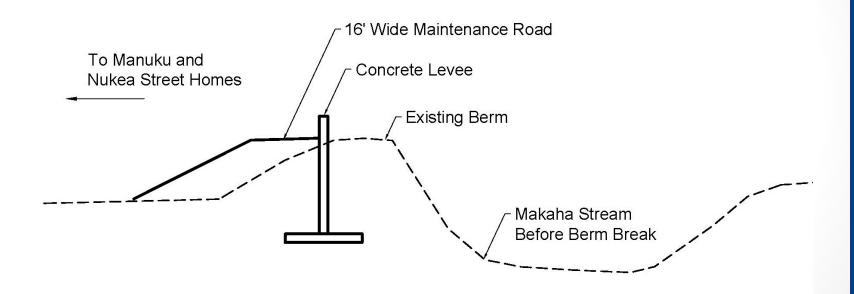
Project No. 04: Mākaha Stream Levee

Makaha Stream Levee

Looking Makai

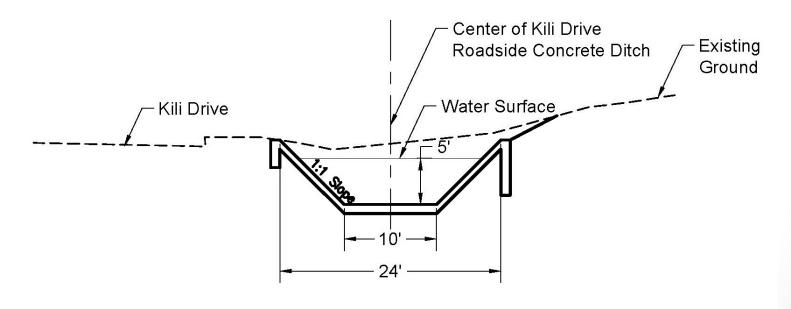
Project No. 05: Kili Drive Channel

Kili Drive - Concrete Channel

Looking Makai

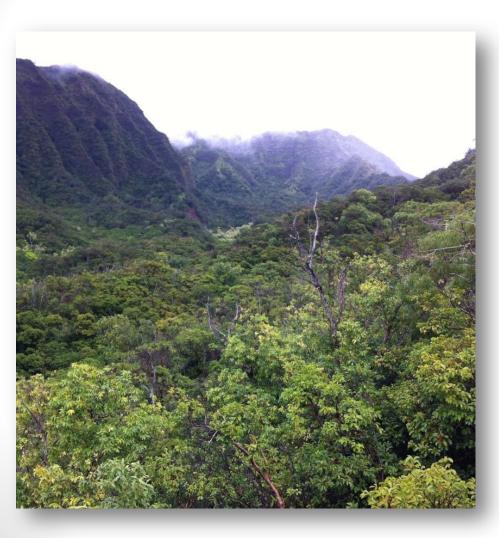
Forest Restoration

- Infiltration rates 2X greater
- 2/3 of valley is forested areas
- Long-range project
- ✓\$500,000 GIA
- ✓\$250,000 BWS
- ✓\$250,000-\$500,000 NRCS grant application

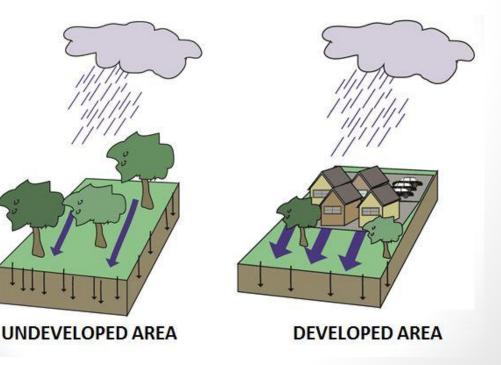
Other Non-Structural Measures

Drainage Improvements required for future development

Any future development of zoned/undeveloped parcels should include a combination of on-site storm runoff detention and improvement of downstream

drainage systems
